**GRANIT**  
QUALITY PARTS

# PISTON SETS PRODUCT BENCHMARK

### PISTON SETS 100 MM

The piston set from GRANIT with part number 38002061 was compared with the piston sets from an OE manufacturer and a European competitor.

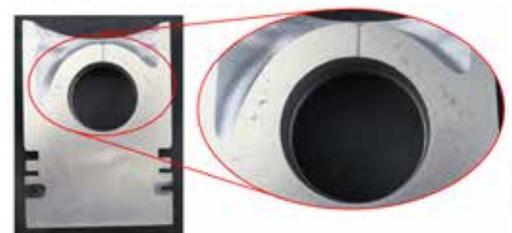
During the macroscopic examination of the pistons, cuts are made through the pistons. The cross sections are examined in detail for cavities and pores. Pistons containing cavities or pores can fail during use and cause major engine damage.

- On the micrographs of the pistons from the OE manufacturer and GRANIT, no cavities or pores are visible.
- On the micrograph of the piston from the European competitor, cavities and pores are visible.
- It was determined that the processing quality of the materials used for the pistons from GRANIT and the OE manufacturer is comparable. Pores and cavities, as discovered in the samples from the European competitor, indicate inferior manufacturing processes that may lead to major engine damage such as piston breakage.
